# SEA COLONY - OCEAN FRONT CONDOMINIUM TOWERS

## INDIVIDUAL EXPERIENCE FOR:

Kenneth R. Christenbury, P.E. & E. Scott Wallis, P.L.S., 2004-2005

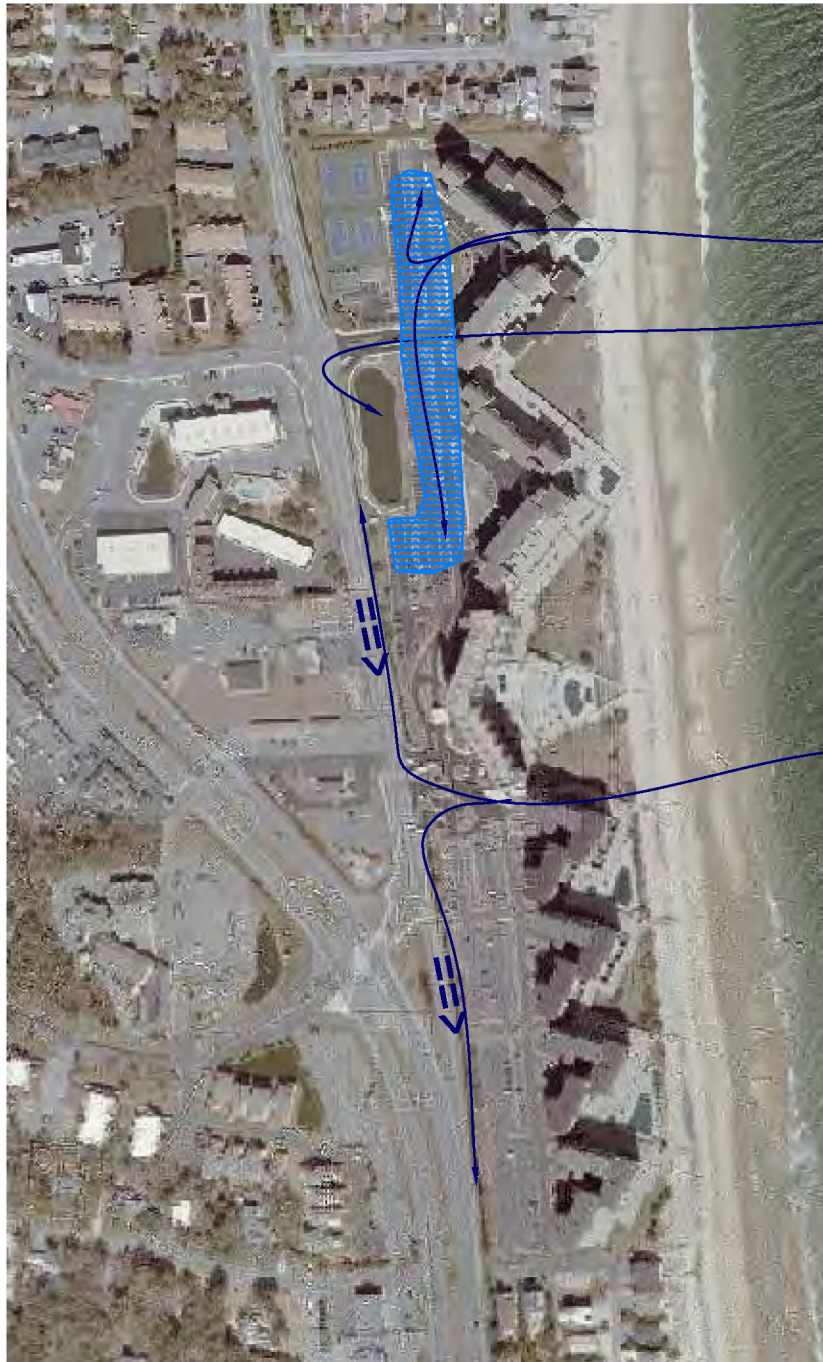
PARKING AREA WITH  
LONG-TERM FLOODING  
PROBLEMS

PRE-EXISTING STORMWATER  
MANAGEMENT FACILITY

DITCH IMPROVEMENTS

The Sea Colony towers were constructed in the 1970's, and experienced problems with aged and failing drainage infrastructure, leading to frequent flooding on the northern parking lot. Mr. Wallis completed a comprehensive utility location survey for the project, coordinated with aerial photogrammetric mapping, resulting in a complete topographic and utility location survey. Mr. Christenbury investigated the feasibility of multiple solutions, including infiltration, permeable pavement, expansion of existing stormwater management facilities, etc. Upon completion of the feasibility review, it was determined that the existing road-side swale along Pennsylvania Avenue had been inadequately maintained, and that the years of neglect were the root cause of the internal problems being experienced by the residents of Sea Colony. Mr. Christenbury coordinated with the Delaware Department of Transportation for a privately funded re-construction of the swale and entrance pipes. The improvements installed provided a cost-effective solution for a long-term problem.
